# PROFESSIONAL INSPECTION REPORT

**Subject**                    123 Any Street  
**Property:**                Northern Colorado

**Client:**                    John and Janice Public

**Inspector:**                Bruce Czech  
Building Consultant/Master Inspector  
ASHI® Certified Inspector # 207435  
Member, Historic Building Inspectors Association

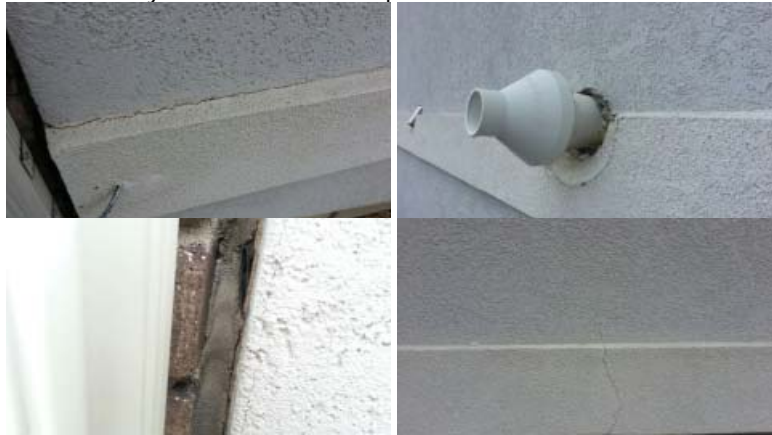
Condition Details: There is some cracking at the lower band. Recommend evaluation and repair by a stucco specialist.

The furnace vent is not sealed correctly.

The joint between the brick and stucco is not sealed correctly at the South west side of the house.

There is cracking in the stucco on the South west side of the stucco. Recommend evaluation by a certified stucco specialist.

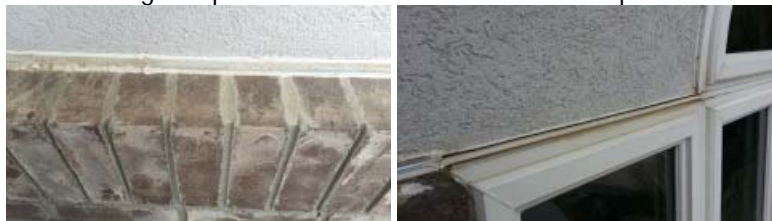
Comments: The flashing doesn't cover the top course of brick work. Inspect regularly and maintain.

The caulking has pulled loose from the windows. Replace the caulking where necessary.

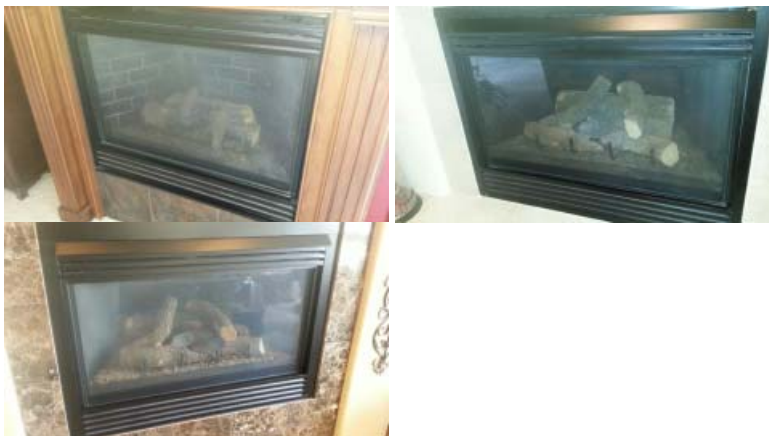
Component Photo:

Location: Family Room. Living room. Master bedroom

Condition Details: There is a nest in the master bedroom fireplace termination. Do not use until it is cleaned out.
